NRL Memorandum Report 4003

Shock Performance of a Shipboard Electrical Switchgear

EDWARD W. CLEMENTS

June 15, 1979

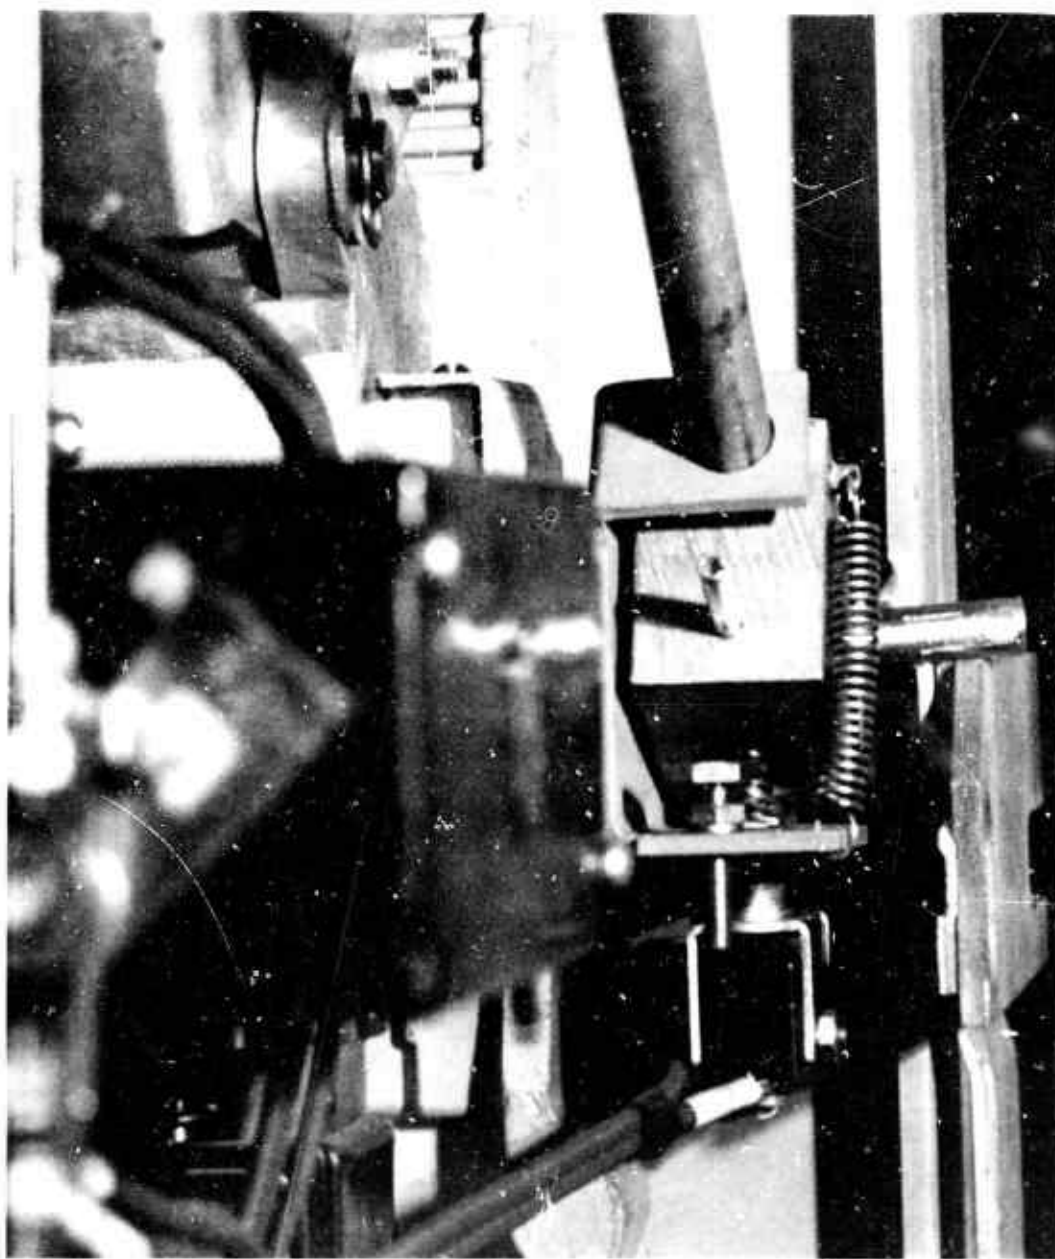
3. The horizontal frame members below the ACB breakers were bent downward from impact by the breakers (Figs. 26, 27, 28, 30, 32, 33 and 35).
4. The interlock mechanisms of the ACB breakers were damaged, those of ACB 1600 No. 2 and the ACB 2400 having their actuator pins bent and that of ACB 1600 No. 1 being knocked out completely (Figs. 28, 29, 32, 34 and 36).

Fig. 36 - Damage from Vertical Shock - lower 1600 A Breaker Com-
partment. Detail of damage to breaker inlock mechanism. (After
blow 3).

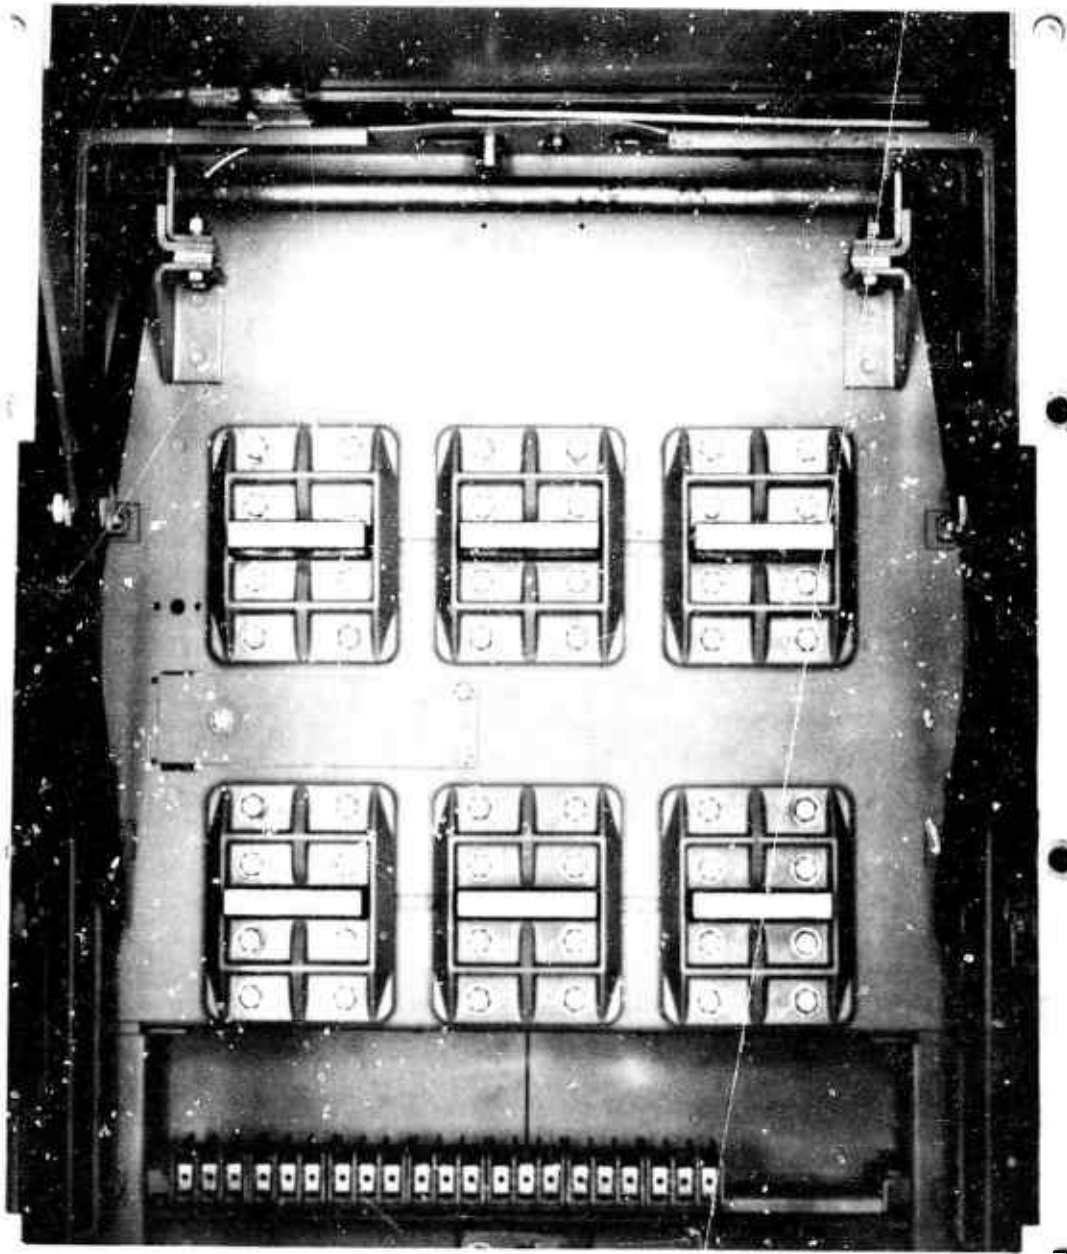
6. One of the brackets holding the frame for the ACB 2400 breaker was broken off, and the upper guide and lock plate was bent. The bolts holding the melamine connector panel sheared, allowing the panel to slip down (Figs. 30, 37, 38, 39 and 40).

Fig. 37 - Damage from Vertical Shock - lower 1600 A Breaker Compartment. Note deformation of breaker support frame. (After Blow 3).

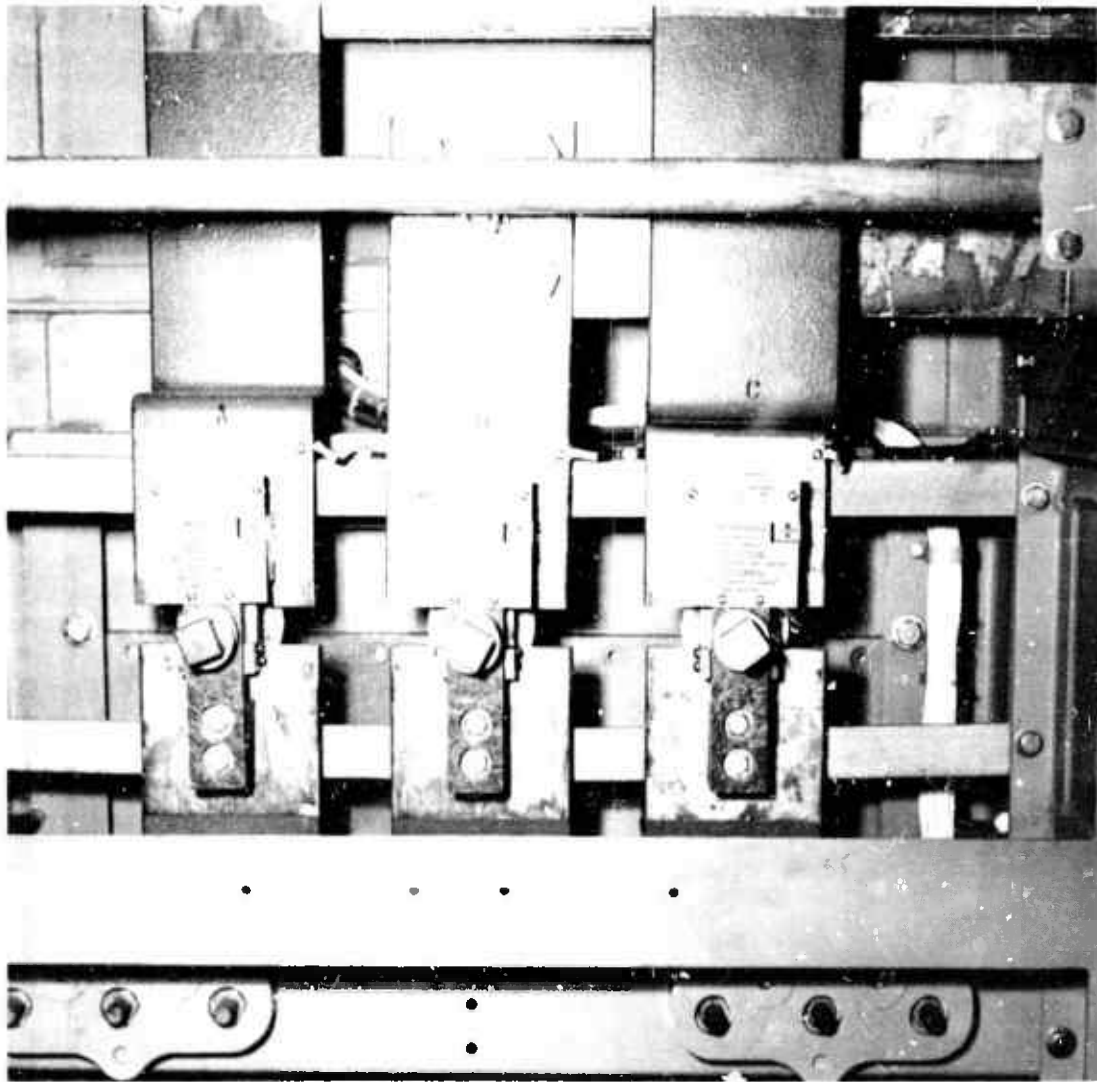
Fig. 38 - Damage from Vertical Shock - 2400 A Breaker Bay (Rear).
Note sheared bolts at top of melamine board (approximately in
line with bus disconnects). (After Blow 3).

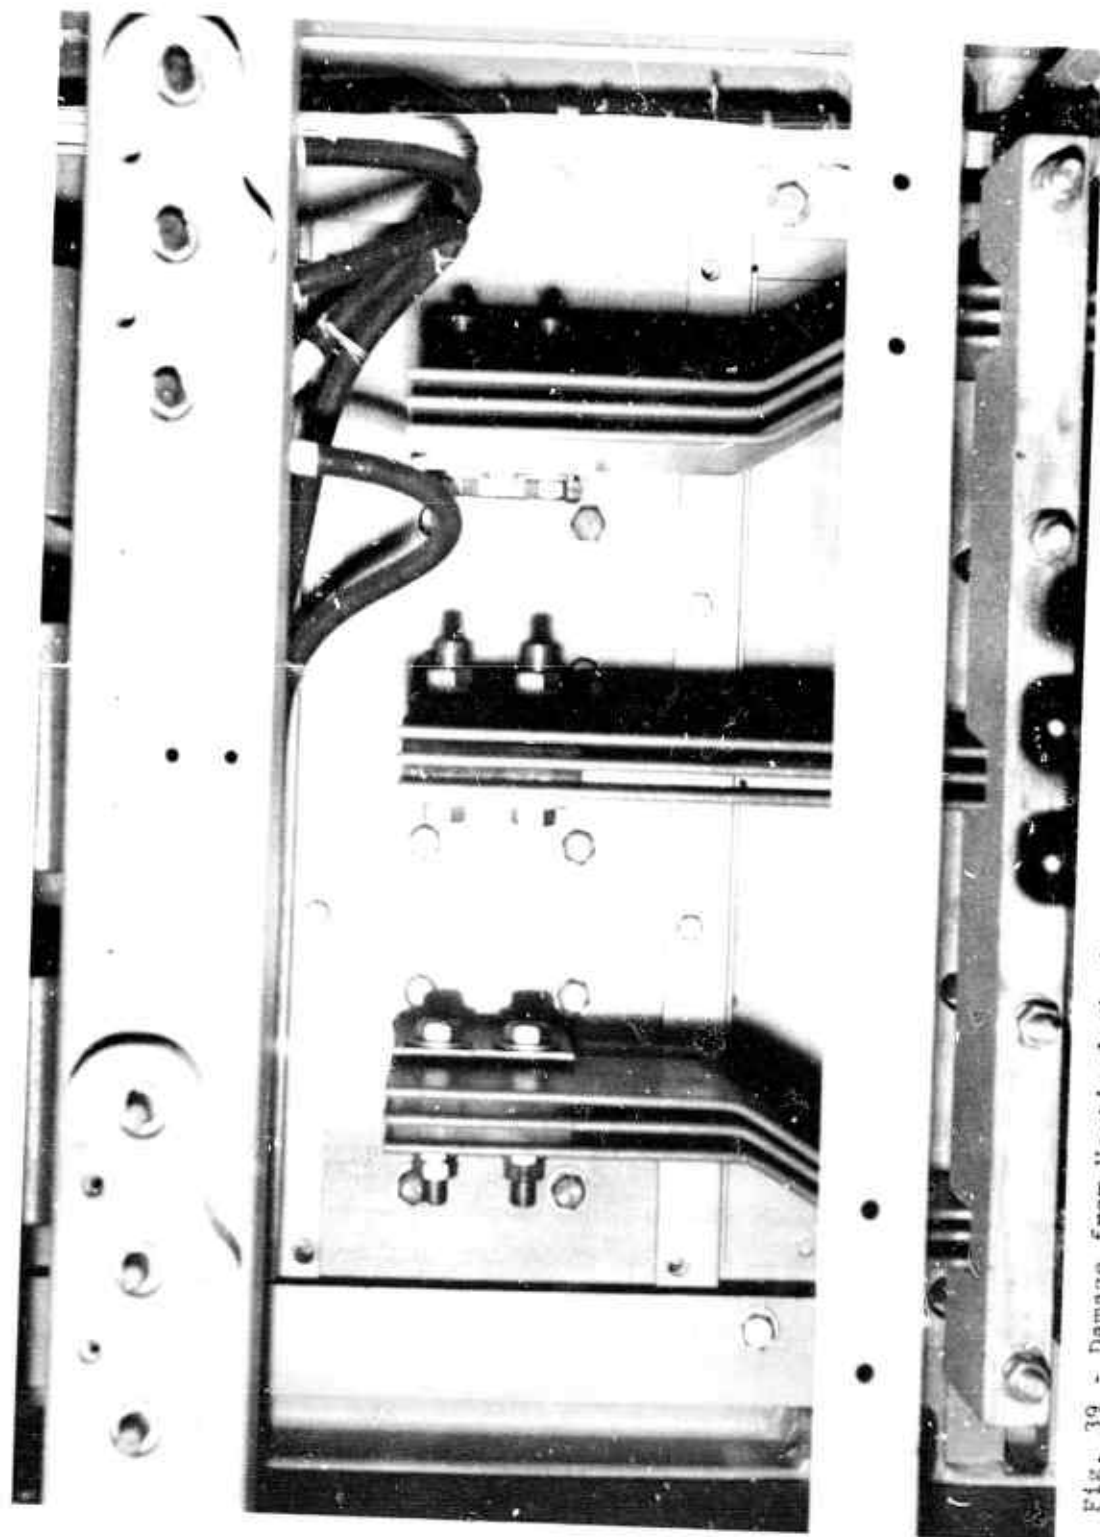
Fig. 39 - Damage from Vertical Shock - 2400 A Breaker Bay (Rear). Sheared bolts in lower half of melamine board. (After Blow 3).

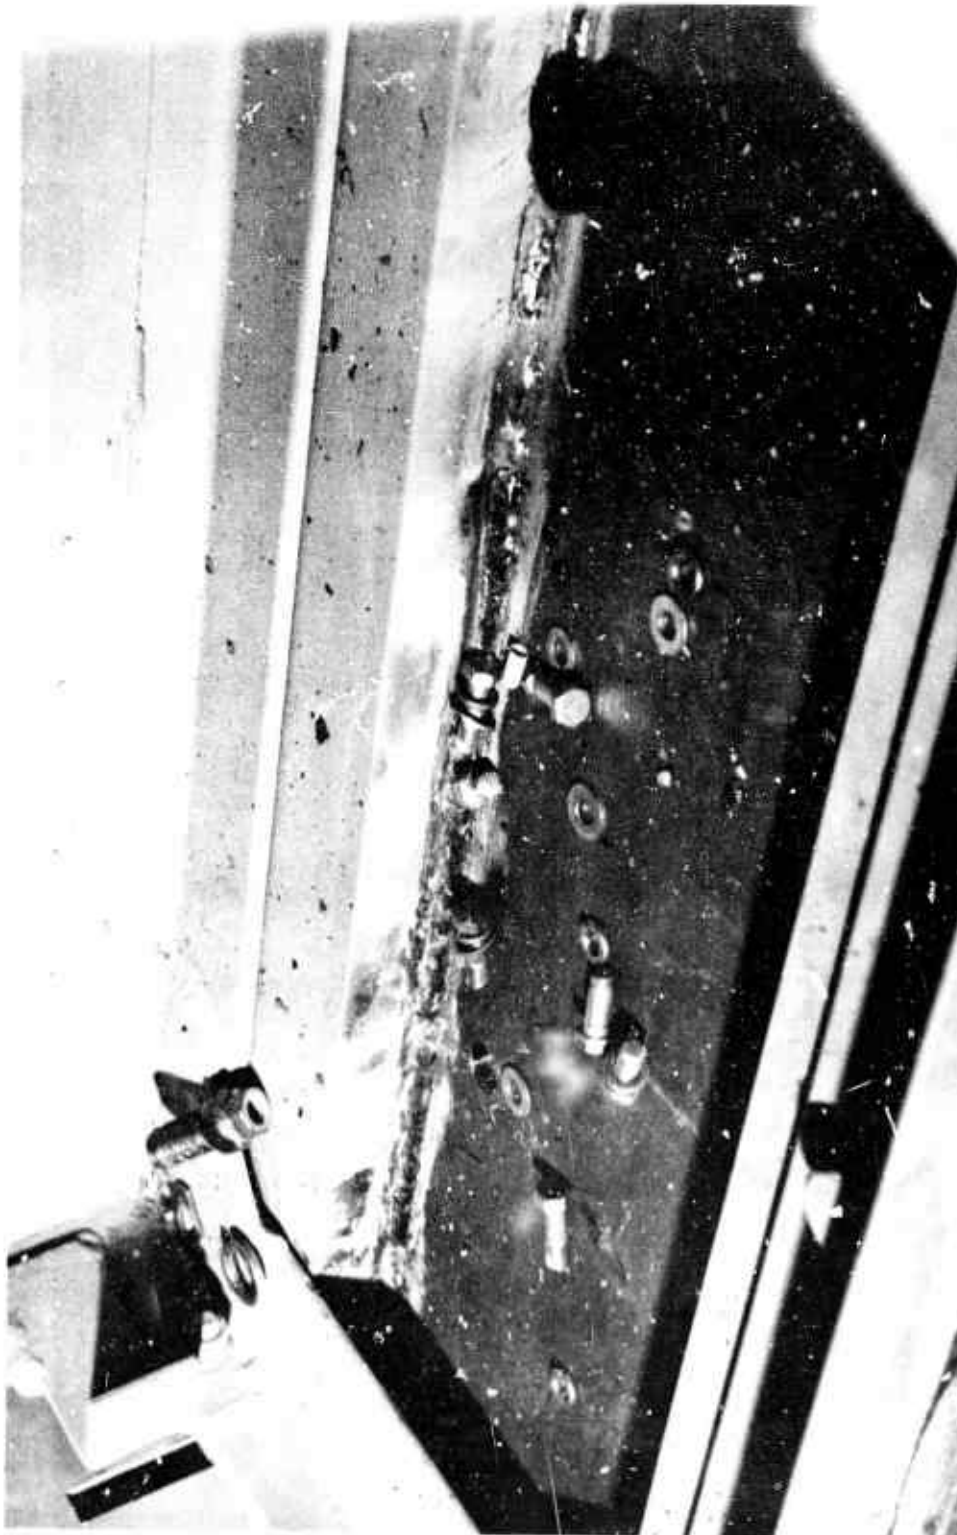
Fig. 40 - Damage from Vertical Shock - 2400 A Breaker Bay (Rear). The smaller bolts were the support bolts for the melamine board. The large bolt at upper left was a switchgear hold-down bolt which was stripped out of the hole in the corner.

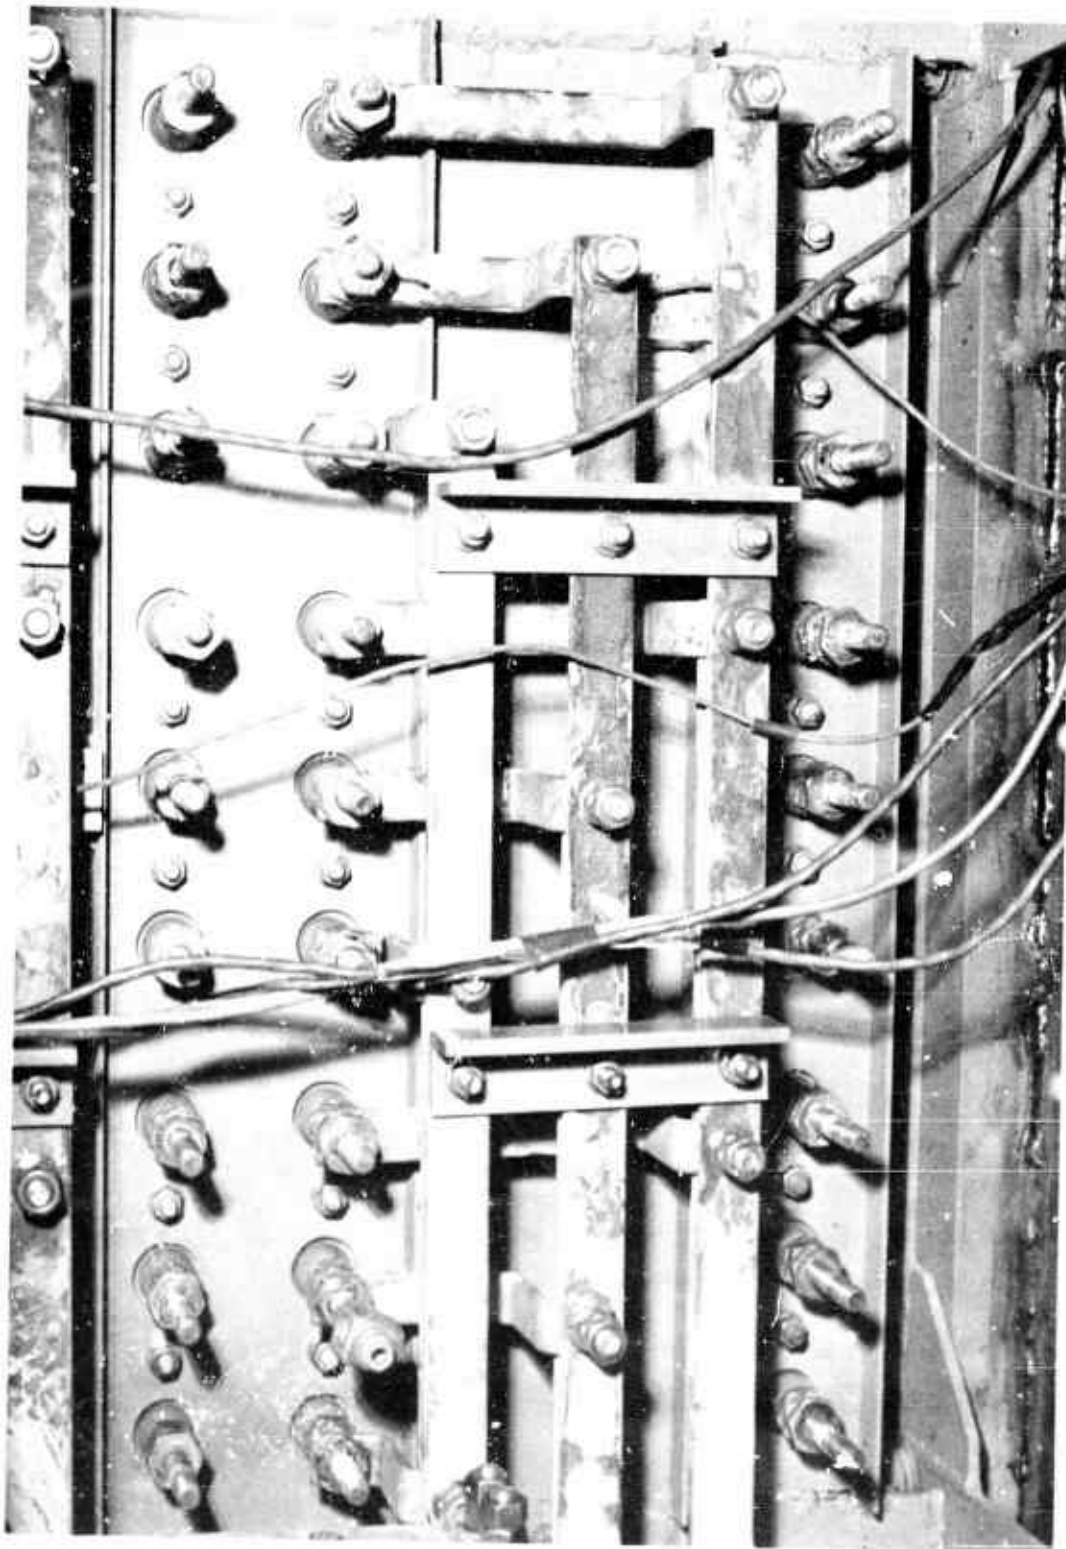
10. The welds attaching the bottom of the AQB mounting panel to the frame of the bay were broken (Fig. 41). Welds were of poor quality, with little penetration. Member edges had apparently been simply butted together without grooving.

Fig. 41 - Damage from Vertical Shock - AQB Breaker Bay (Rear). Note cracked welds at each end of the lower frame member. (After Blow 3).

Only the major damage was repaired - broken welds were gouged out and rewelded, broken bolts drilled out and replaced with high-strength bolts. The damage louvers on the ACB door-panels were stripped off entirely as they were a hazard to accelerometer cables. Bent frame members, slipped hinges, etc. were not repaired since similar damage could be predicted on the next blow with high confidence. When the test was

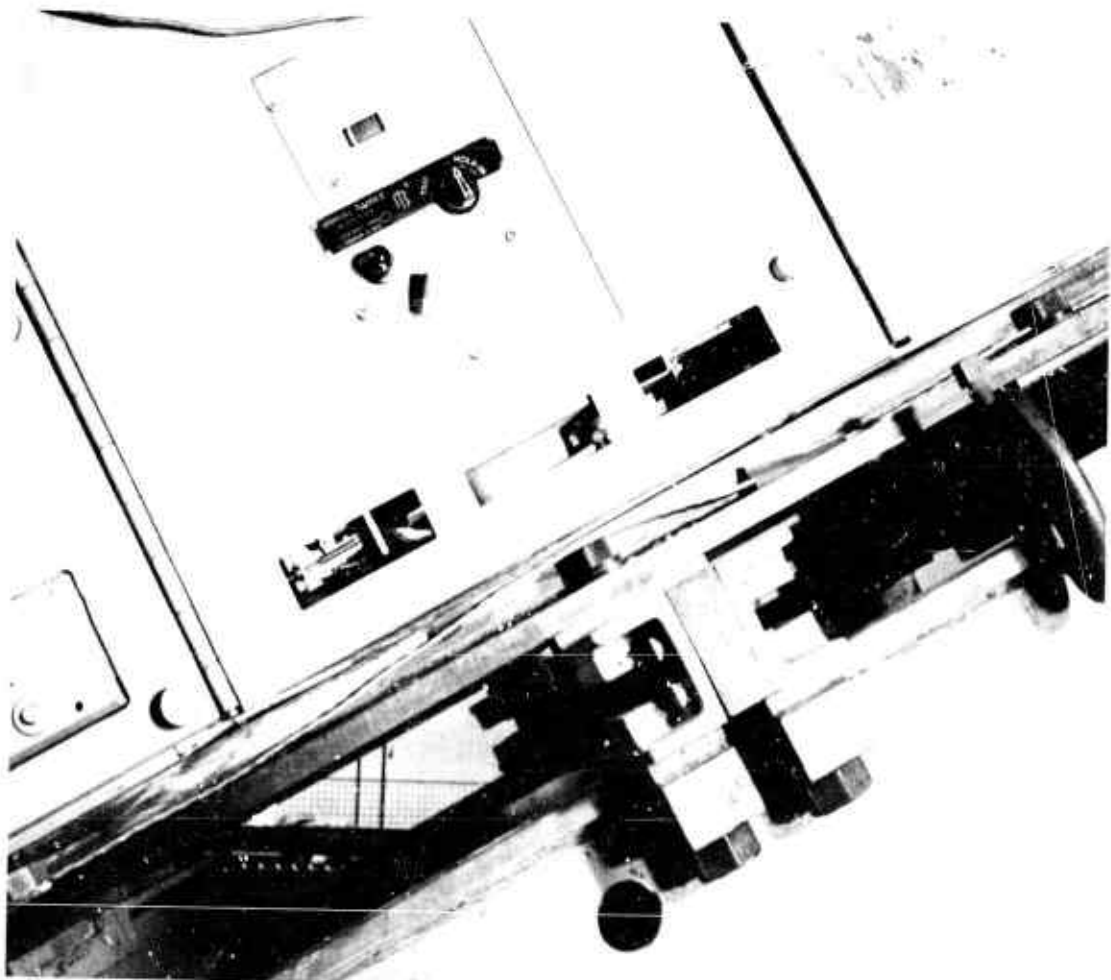
Only minor damage such as slipping of door-panels and the fuse panel was noted as the test progressed. However, inspection after Blow 6 located fractures and deformation in the front bottom frame members at the bay junctions (Fig. 42) accompanied by loosening of the hold-down bolts in the vicinity. One hold-down bolt, in the corner of the ACB-1600 bay adjacent to the junction with the ACB-2400 bay, was stripped out. Replacing this bolt and tightening the loose ones drew the frame back down in contact with the channels. No other repairs were made.

Fig. 42 - Damage from Vertical Shock. Note breakage and deformation of switchgear base frame member below bay junctions. Switchgear is oriented for Inclined Shock. (After Blow 6).

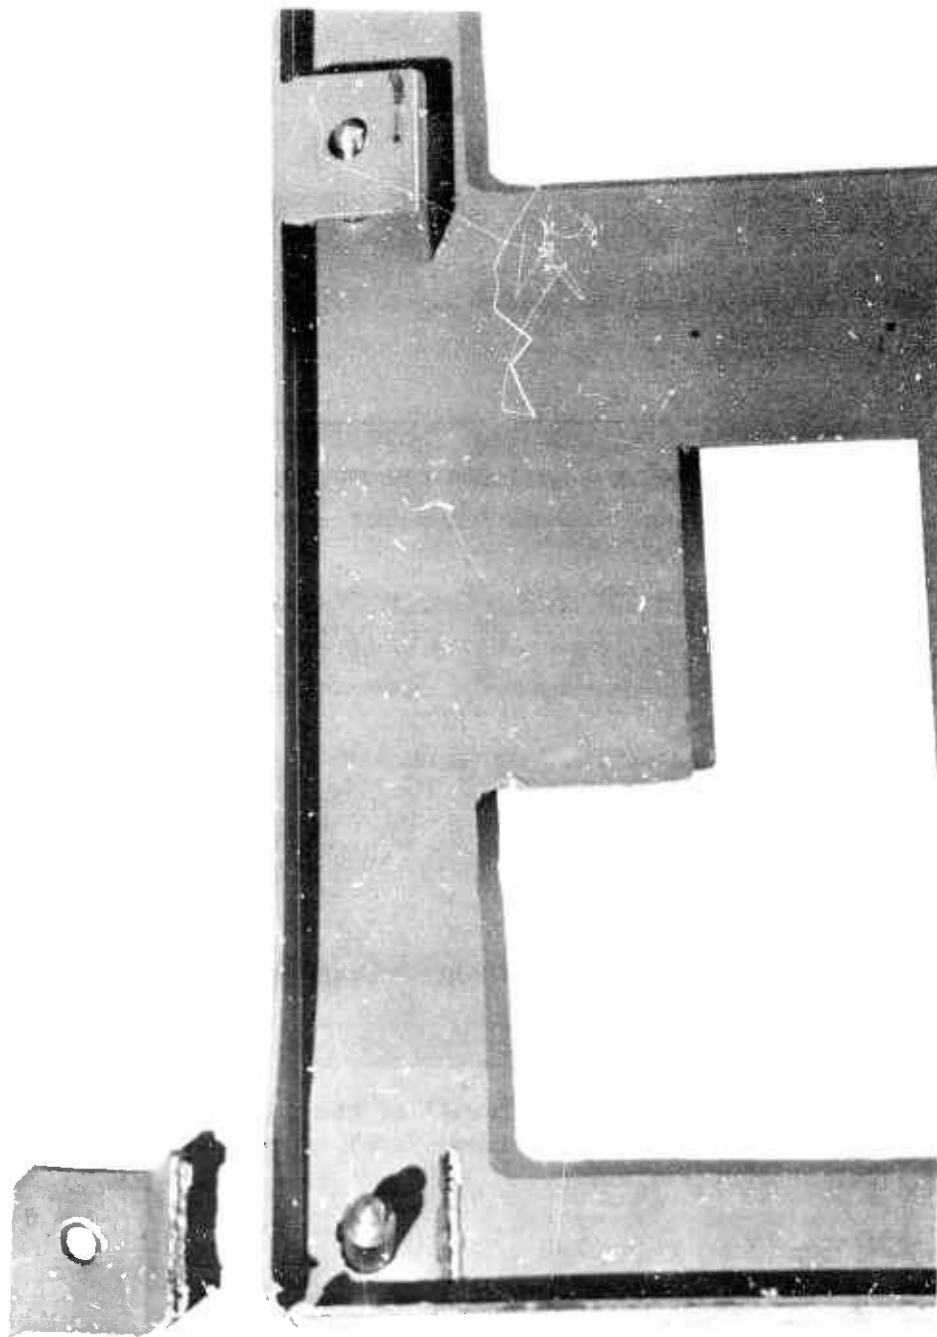
Fig. 45 - Damage from Shock Test. Broken corner and support of LF250 cover panel.

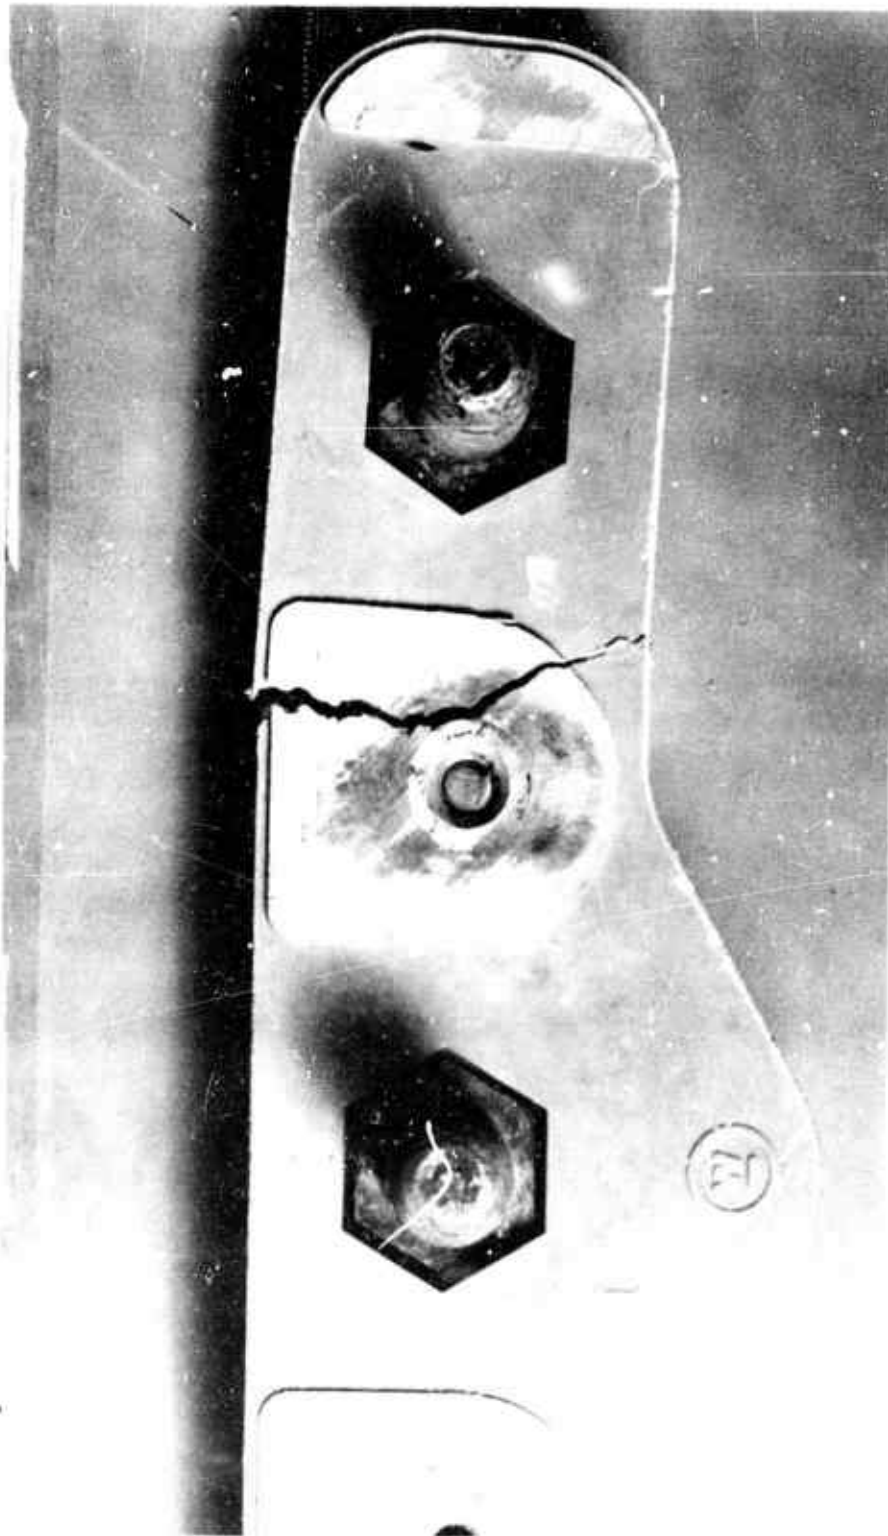
Fig. 46 - Damage from Shock Test. Broken upper mount and sheared breaker hold-down bolt for LF250 No. 9.

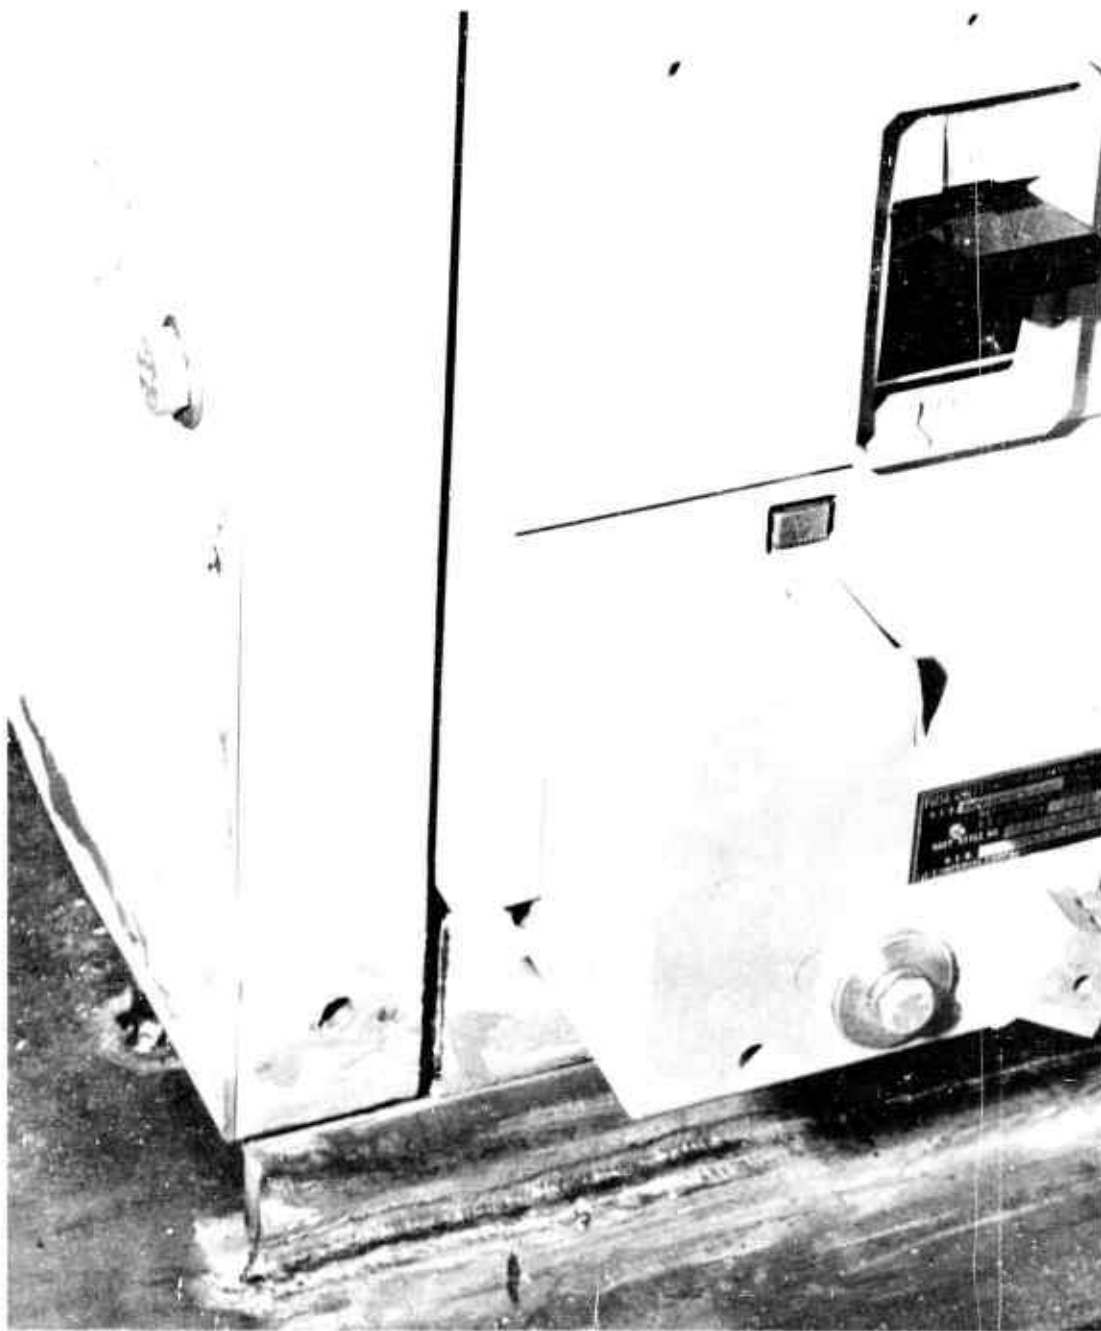
Fig. 48 - Damage from Shock Test - AQB Breaker Bay. Outer Vertical frame member broken completely loose at base of frame, and shifted outboard 1/4".

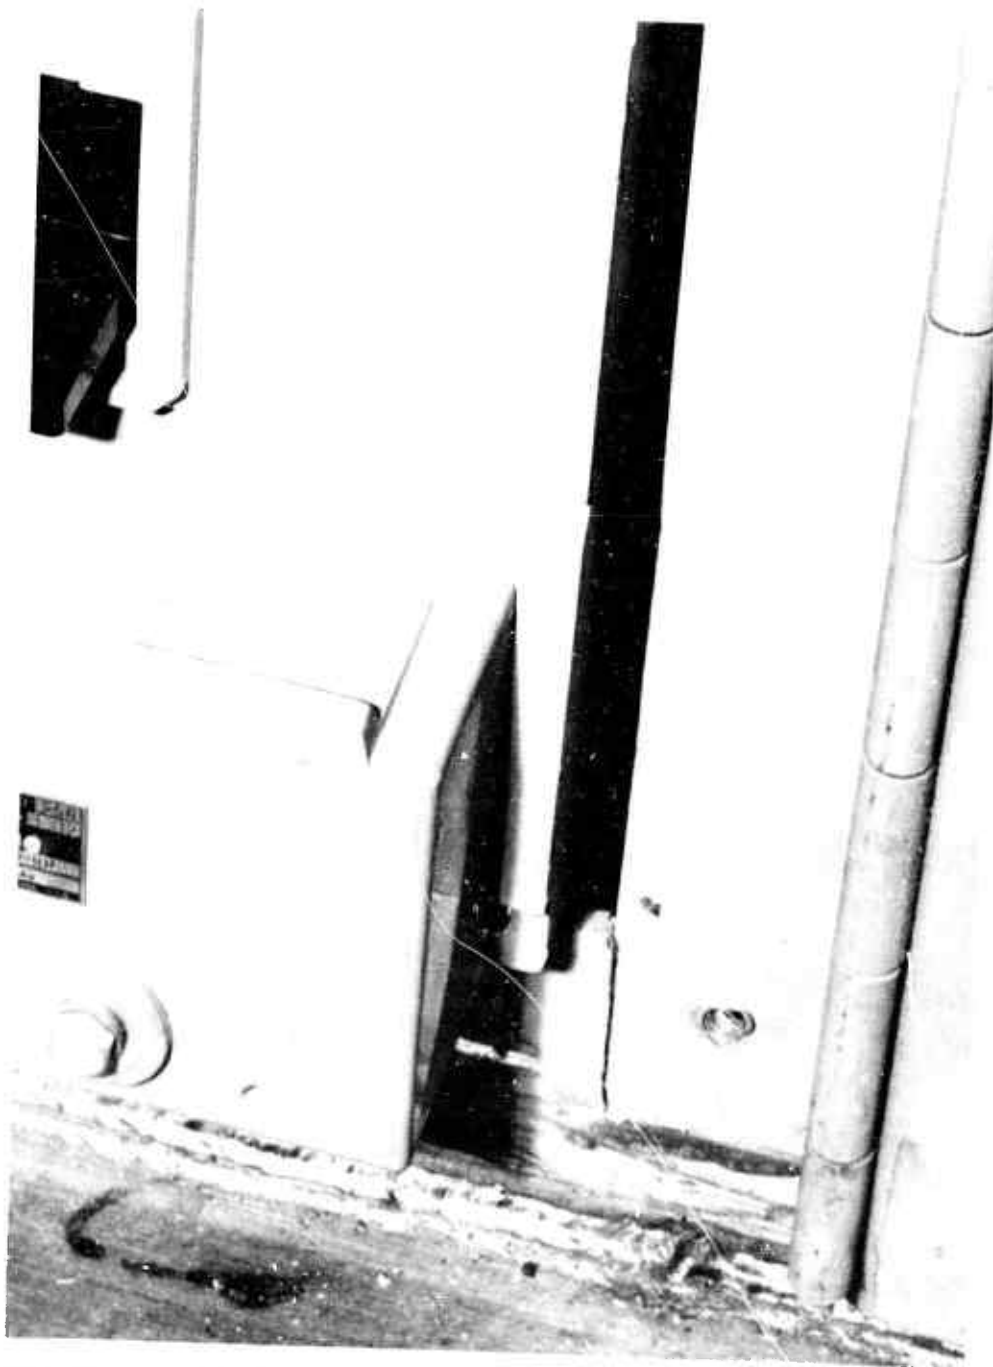
Fig. 49 - Damage from Shock Test - AQB Breaker Bay. Inner vertical frame member broken loose at base, and horizontal bottom member shifted over.

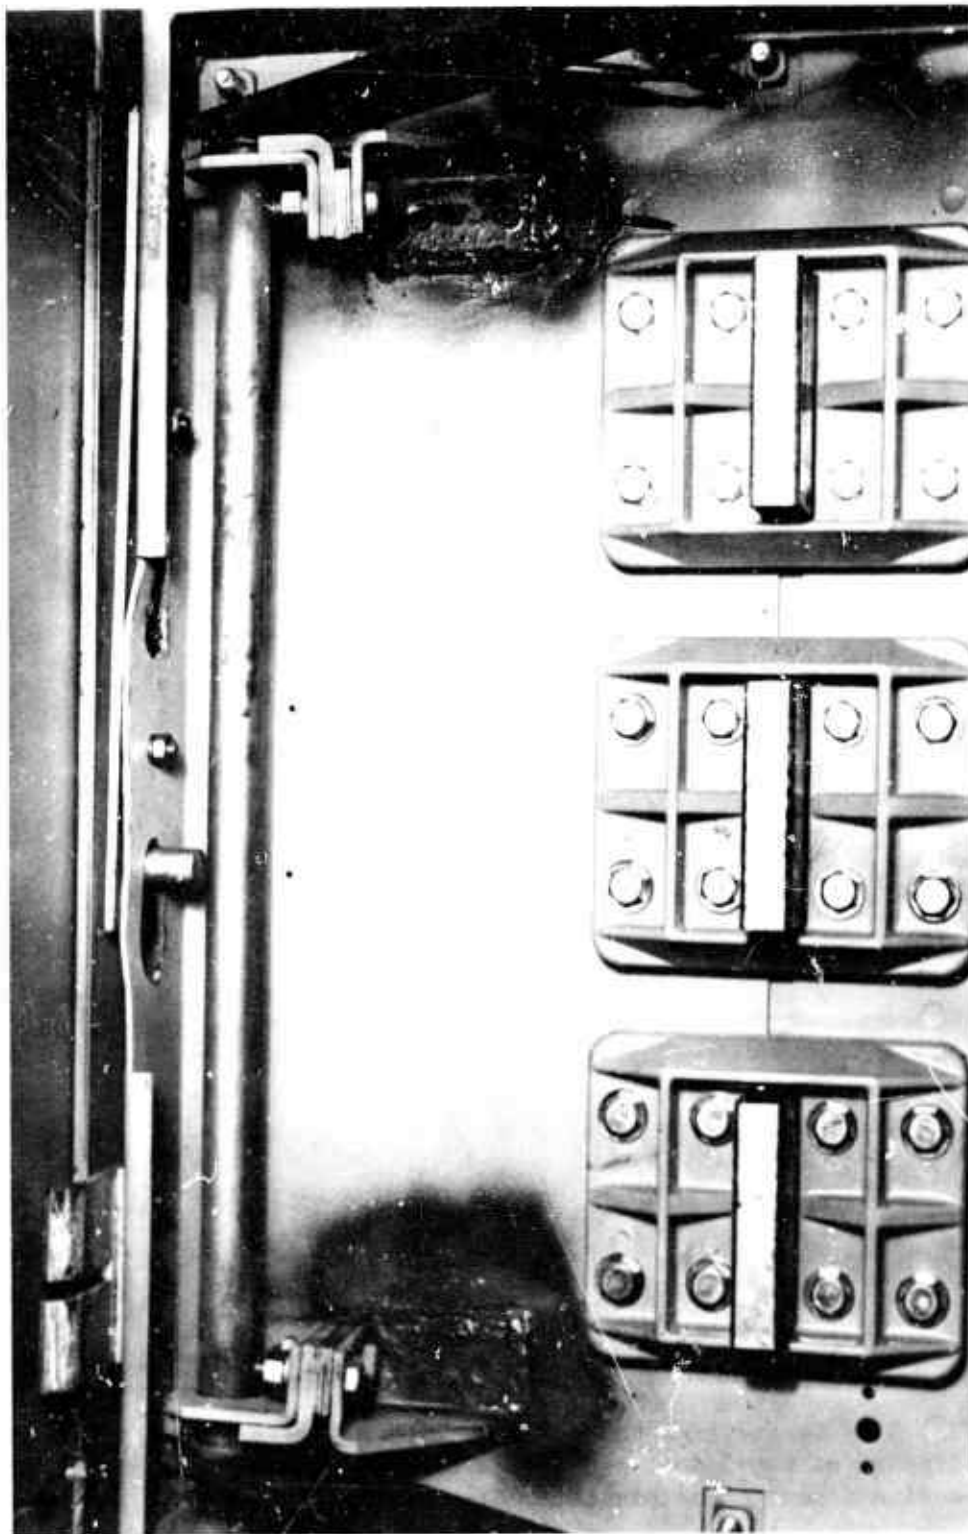
Fig. 50 - Damage from Shock Test - upper 1600 A Breaker Compartment. Damage to breaker support frame.

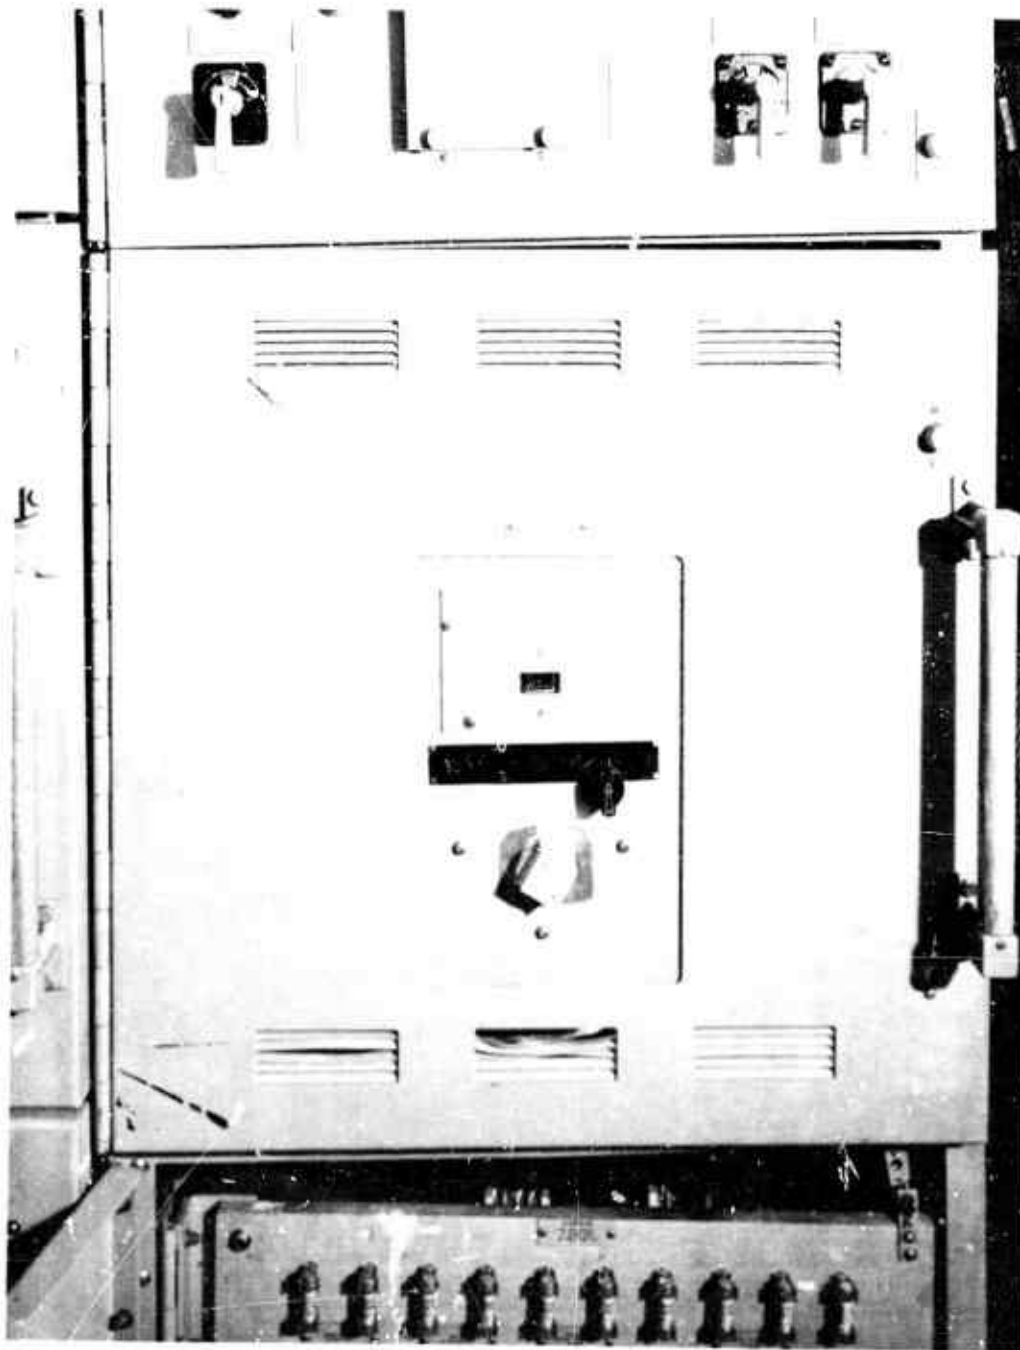
Fig. 51 - Damage from Shock Test - 2400 A Breaker Bay. Note slippage of panel door and damage to louvers, slippage of fuse panel and damage and panel and fasteners.

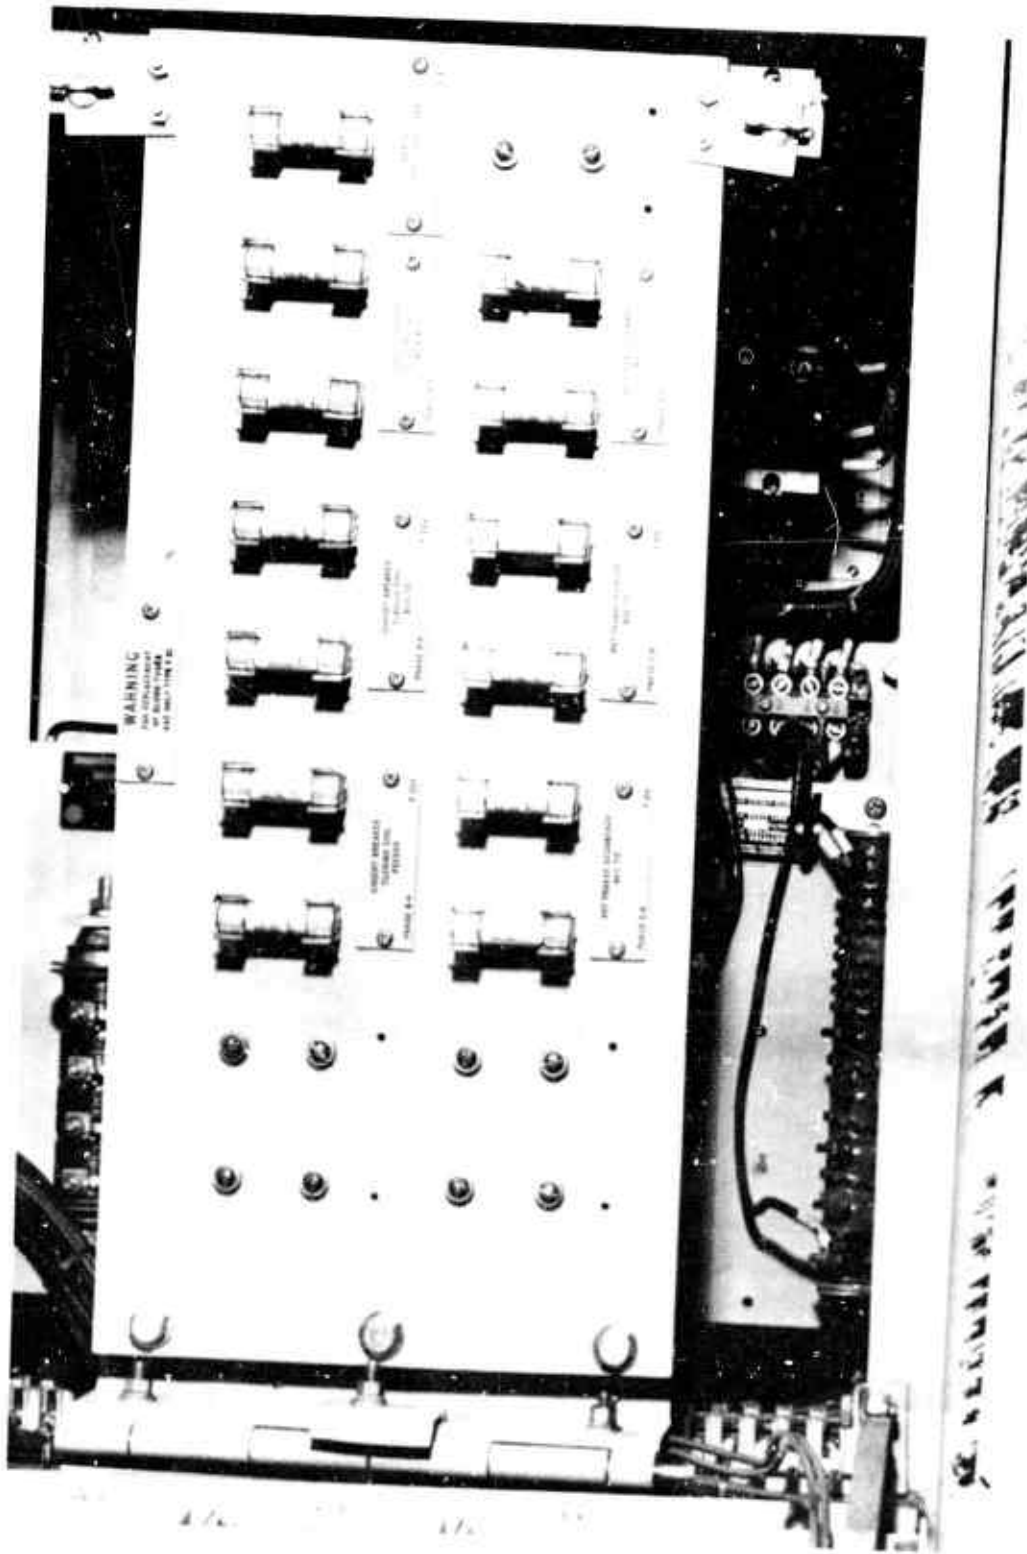
Fig. 52 - Damage from Shock Test - Fuse Compartment. Note slippage of fuse panel hinge and travel of hinge pin.

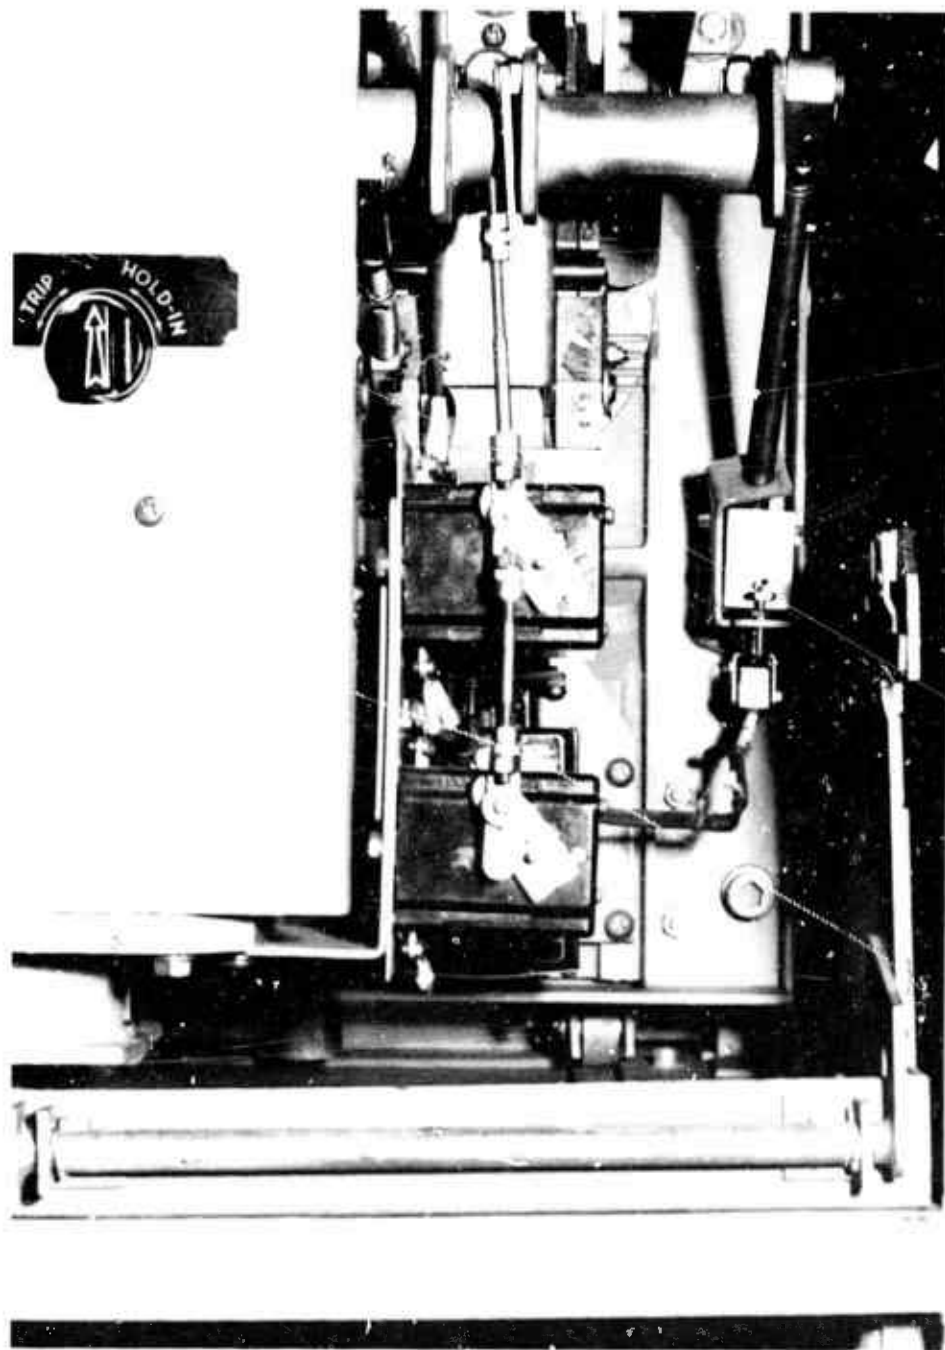
Fig. 53 - Damage from Shock Test - 2400 A Breaker Compartment.
Note damage to interlock mechanism and deformation of accessory
bracket and linkage.
